THAMES RIVER BASIN
LEICESTER, MASSACHUSETTS

SARGENT POND DAM
MA 00986

PHASE I INSPECTION REPORT
NATIONAL DAM INSPECTION PROGRAM

MAY 1980

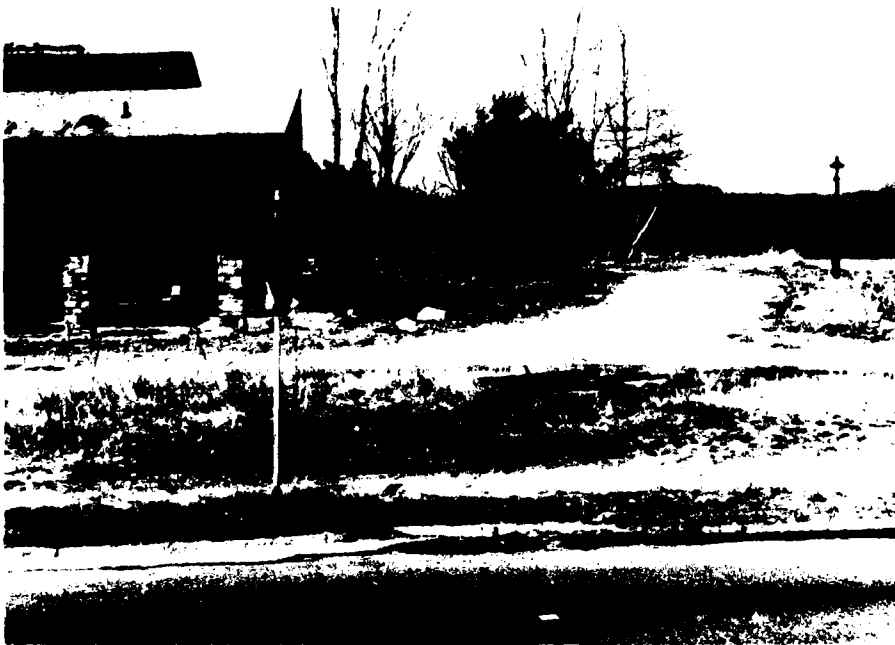
The right embankment is about 136 ft. long and has a crest width of about 300 ft. A private home is located on the upstream part of the crest. State Route 9 crosses the downstream end of the sloping crest. A vertical rubble masonry retaining wall extends along the portion of the embankment immediately adjacent to the spillway. Mortar is missing from some of the joints of this wall. The remainder of the upstream slope is irregular, with random rock riprap along some areas. Along other areas there is gravel or grass. There are also many mature trees and some light brush growth on the upstream face of the embankment. In general, the right embankment appears to be in good condition (see Appendix C, Photo Nos. 1, 3 and 4).

4. Downstream slope of right embankment.

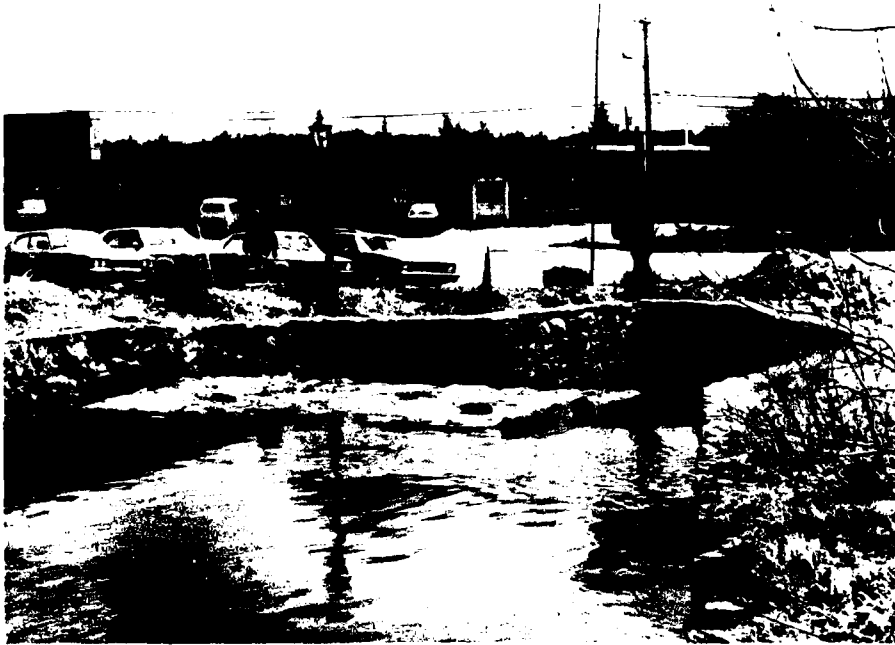
c. Appurtenant Structures. The 30.3 ft. long spillway of the dam is a concrete and rubble masonry broad crested weir. There is a 9.8 ft. long and 1.7 ft. deep notch in the spillway crest which has provisions for flashboards and pins. At the time of the inspection there were 10 in. high flashboards installed in the spillway notch. Because of the high flow condition at the time of inspection, the condition of the flashboards could not be determined. The spillway training walls are about 2.5 ft. above the spillway crest. There is mortar missing from the joints of the training walls. There is minor seepage through the left portion of the spillway overflow section. At the downstream toe of the spillway a 5.8 ft. wide by 8.3 ft. high stone box culvert carries the outflow under State Route 9 to Town Meadow Brook. The culvert had some mortar missing from joints, but was in generally good condition (see Appendix C, Photo Nos. 5, 6, 7 and 8).

5. Overview of spillway crest.

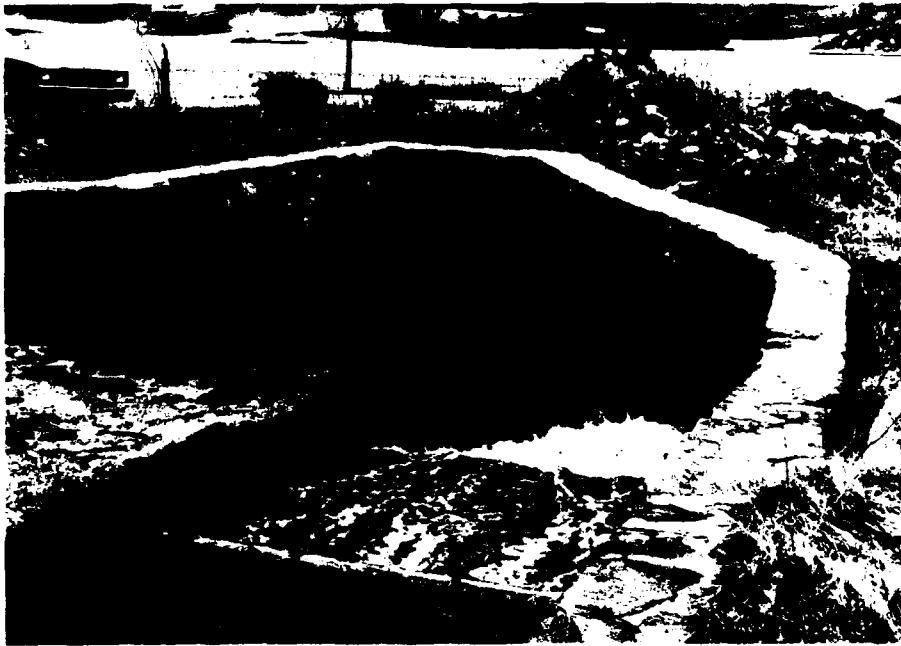
7. Upstream entrance to stone box culvert under Route 9.
